DECLARATION OF CHRISTOPHER G.  
BETKE IN SUPPORT OF DEFENDANT'S  
MOTION TO EXCLUDE THE  
TESTIMONY AND OPINIONS OF KEN  
RICE

## **THE BLUFFS AT EVERGREEN FIRE INVESTIGATION REPORT**

Insured: DH&G LLC  
Loss Location: 2 West Casino Rd.  
Everett, WA 98204  
Date of Loss: December 31, 2015  
File Number: 220.19486  
JH File Number: 1C0703257

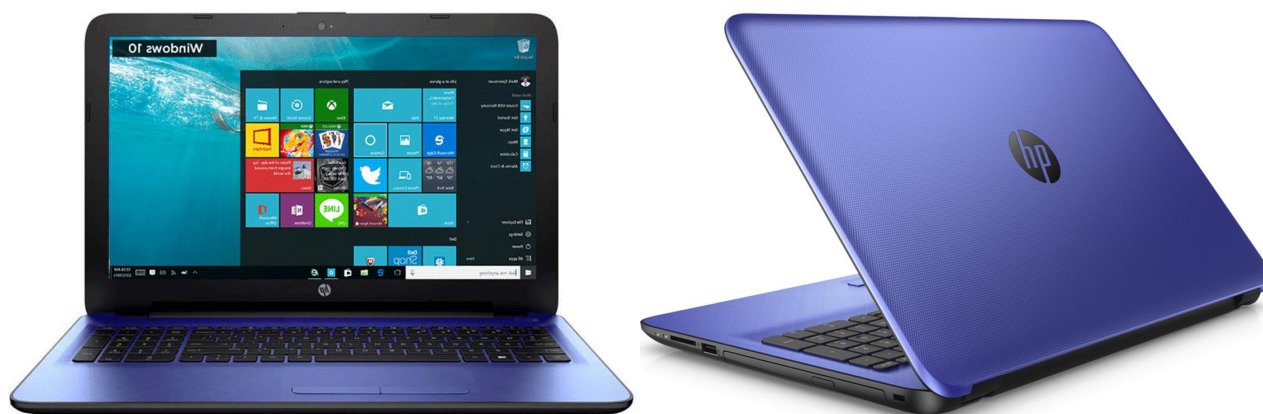
**Figure 7: Exemplar HP laptop.**

1. Exemplar Laptops: Exemplar refurbished HP laptops were purchased for comparison purposes (Figure 7).

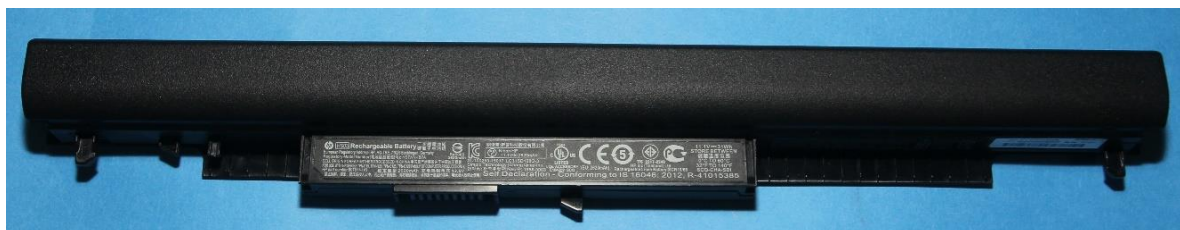
- a. The laptops came with three-cell Li-ion battery packs (Figure 8 and Figure 9) with the following specifications:
  - i. HS03 Rechargeable Battery
  - ii. HP Part Number: 807611-141 or 807956-001
  - iii. Serial Numbers: 6EZRP04WY8VLD0 and 6EZRP04WY8W0HF
  - iv. Specifications: 11.1V, 31Wh, 2620mAh

**Figure 8: IMG\_0039, SAS, 10/31/16: Battery pack from exemplar HP laptop.**

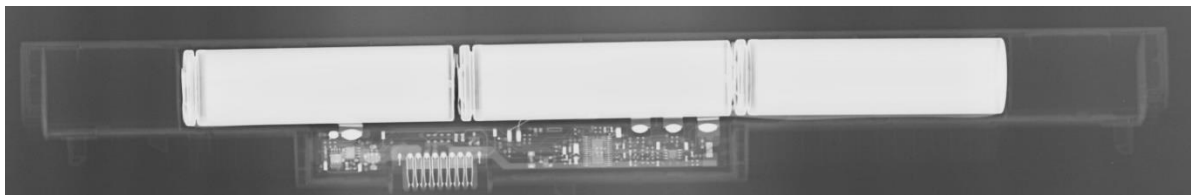
**Figure 9: X-Ray image of exemplar battery pack showing the three internal Li-ion battery cells.**
